MISCELLANEOUS PAPER HL-79-7

PUMPING STATIONS - FIELD PERFORMANCE INVESTIGATION

U. S. Army Engineer Waterways Experiment Station
P. O. Box 631, Vicksburg, Miss. 39180

July 1979

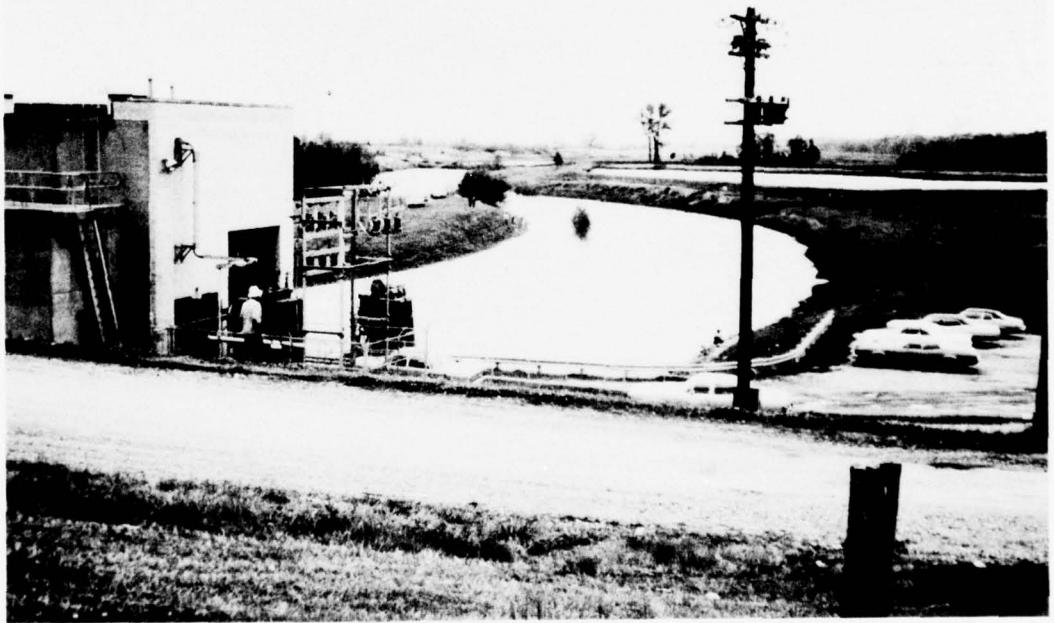
5. A variety of the straight and curved approach channels observed are shown in Figures 1-8. Observation of flows in various geometric shapes and alignments of approach channels (Figures 1, 4, 5, and 6) indicated that flow conditions at the pumps were more favorable with long, straight approach channels. At some structures the sump was skewed relative to the approach channel. In most cases it appeared that more consideration was given to the design of the approach channel to the gravity flow structure than to the approach channel to the pumping station (Figure 8).

Figure 2. Approach channel with reverse curve

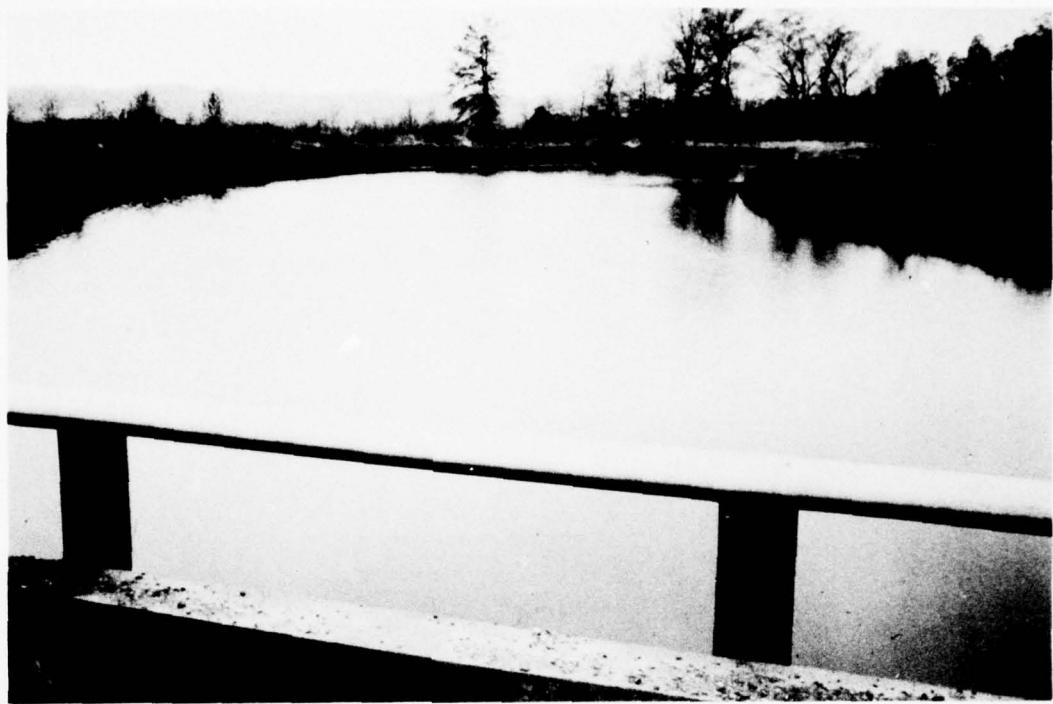
Figure 3. Curved approach channel viewed from pumping station

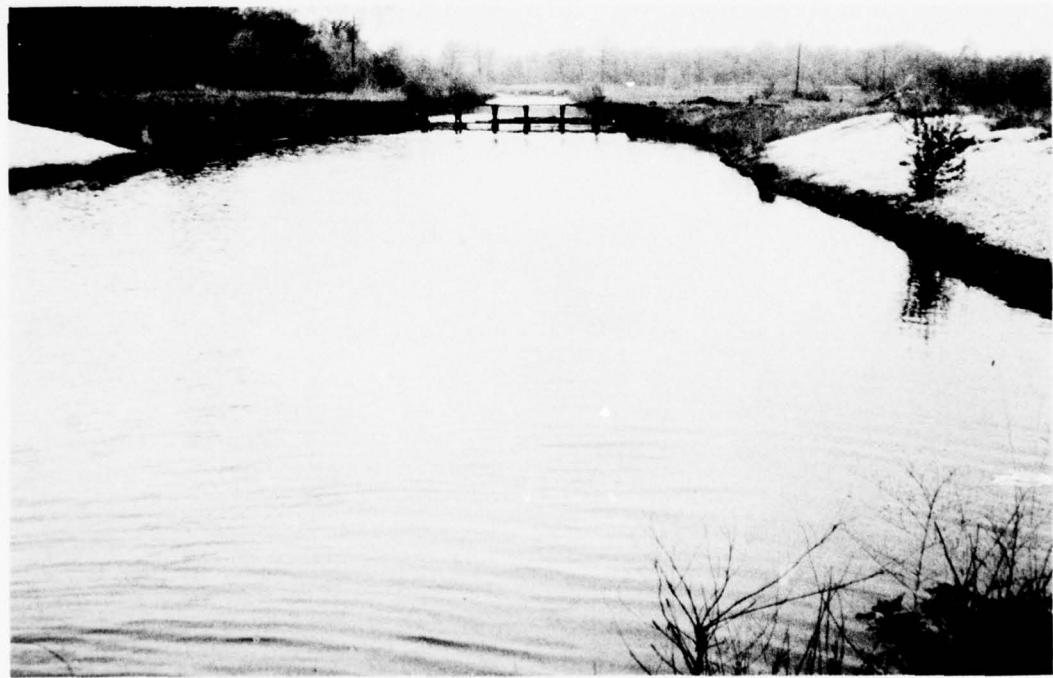
Figure 4. Straight approach channel viewed from pumping station
(trashrack in background)

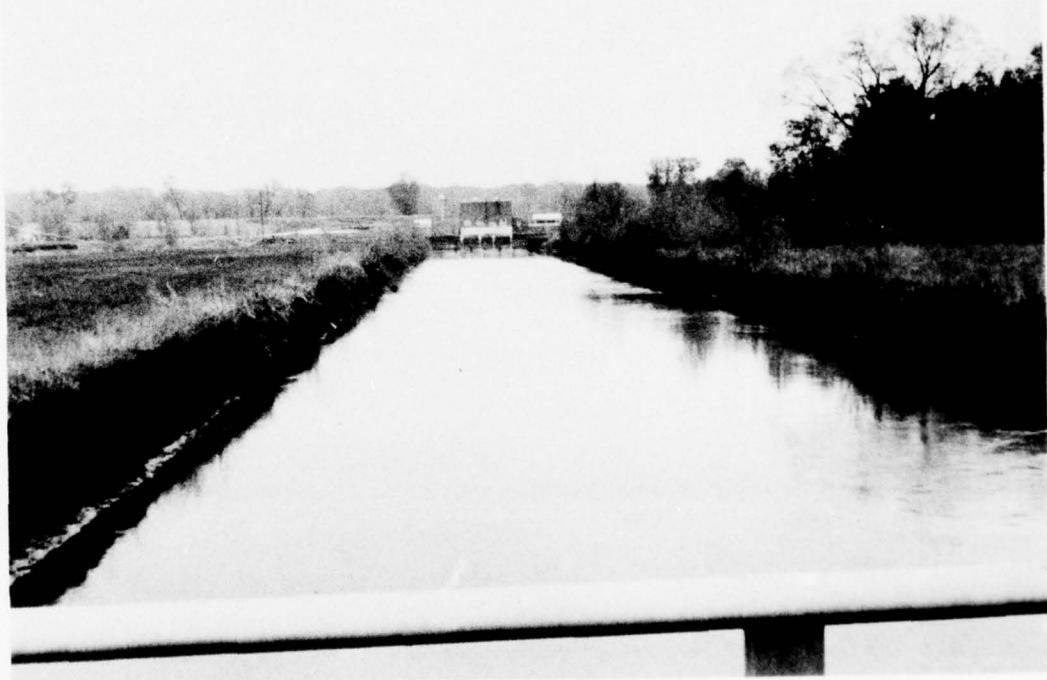
Figure 6. Long reach of straight approach channel

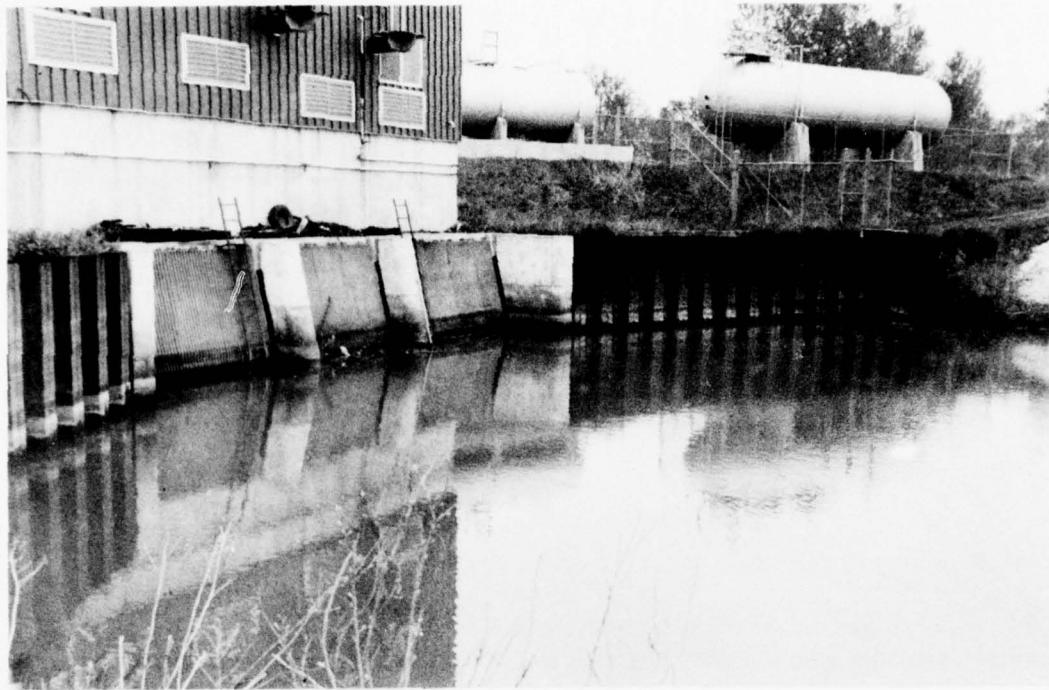
6. Various types of entrances to sumps were observed (Figures 9-17). It appeared that the transition from the approach channel to the sump was a major factor affecting the hydraulic performance of several pumping stations. These stations had inadequate transitions consisting of abrupt abutment walls that tied into the side slopes of the approach channel at a 90-deg (1.6-rad) angle (Figures 10 and 18). Flow passing abrupt changes in geometry tended to separate from the sidewalls and an eddy would usually form as shown in Figure 18a. Stations with 45-deg (0.8-rad) wing walls also experienced flow separations (Figure 17), although not as severe as those observed with the 90-deg wing walls. The eddies and uneven flow distribution to the pumps can be reduced or eliminated by streamlining the transition from the approach channel to the sump. A streamlined transition usually consists of vertical quadrant walls between the side slopes of the approach channel and the entrance of the sump (Figure 18b). Flow separation at the upstream end of the pump divider walls was improved by the use of streamlined rather than square pier noses (Figure 19).

Figure 9. Entrance to sump, 45-deg wing walls, rounded pier noses,
three pumps operating

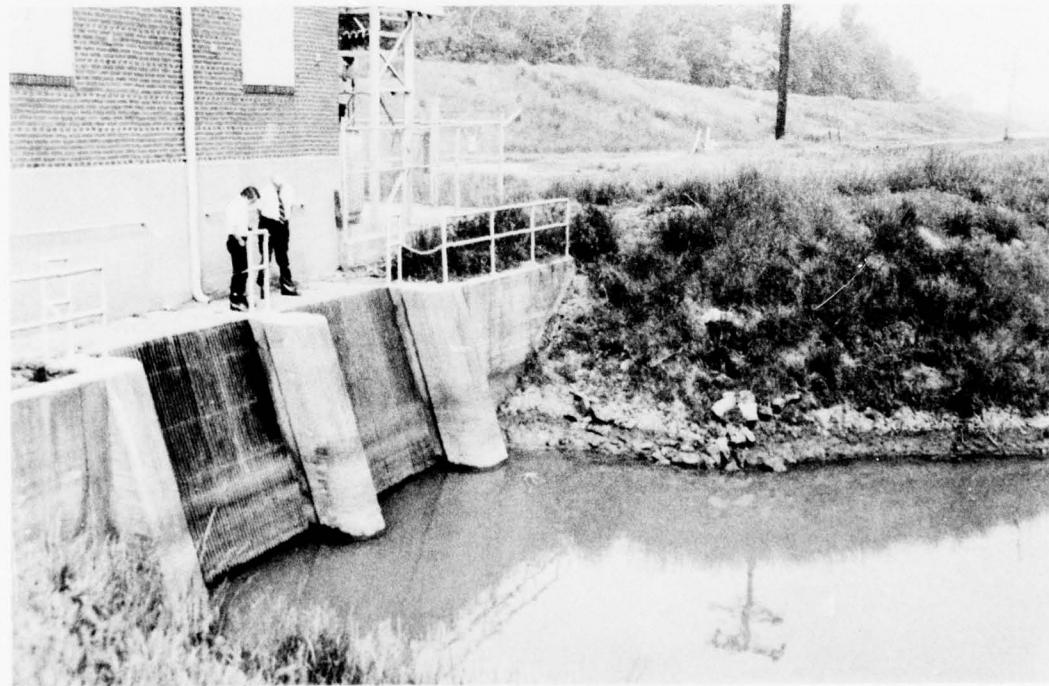
Figure 10. Entrance to sump, 90-deg wing walls, rounded pier noses,
pumps not operating

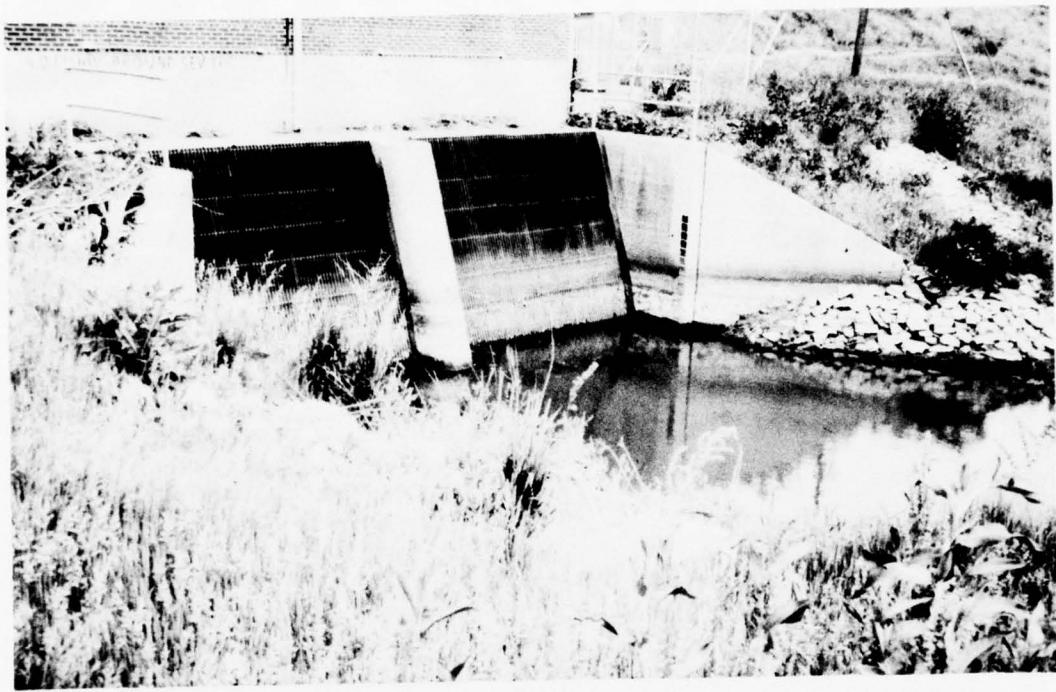
Figure 11. Entrance to sump, 45-deg wing walls, rounded pier noses,
pumps not operating

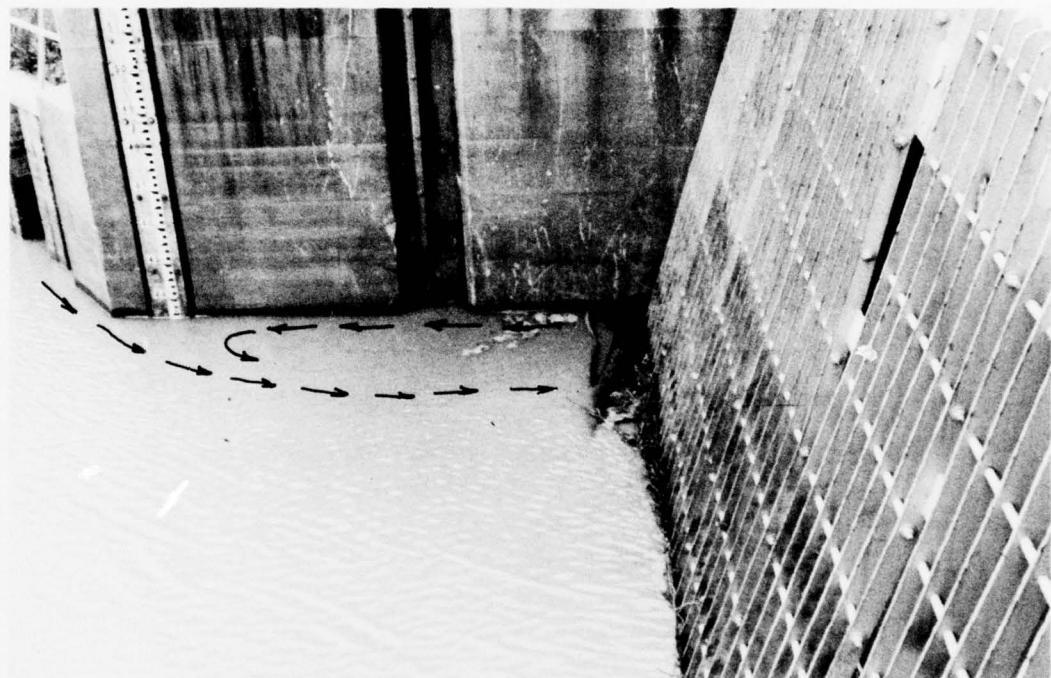
Figure 17. Entrance to sump, 45-deg wing wall,
adverse circulation

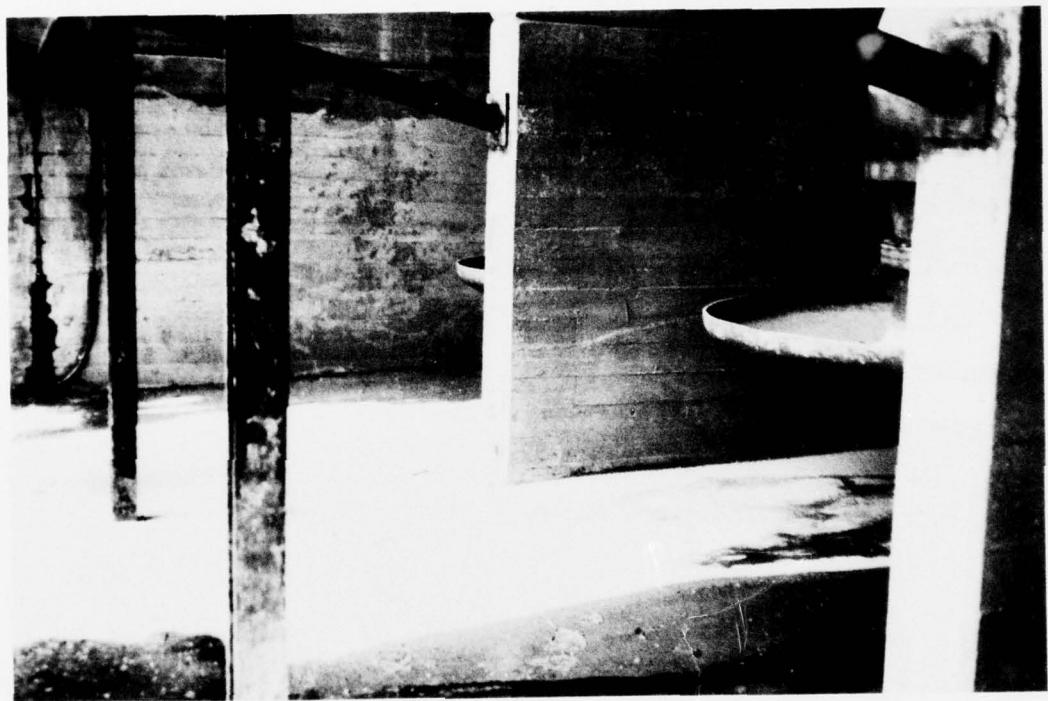
Figure 22. Typical placement of umbrellas and divider walls in sump

9. Certain devices were reported to have improved the hydraulic performance of several sumps. At some stations, it was reported that the hydraulic performance was improved by the addition of umbrellas to the pumps (Figures 21 and 22), which were considered to have streamlined the direction and reduced the magnitude of intake velocities. Vanes (Figures 23 and 24) have been located below the pump intake to guide

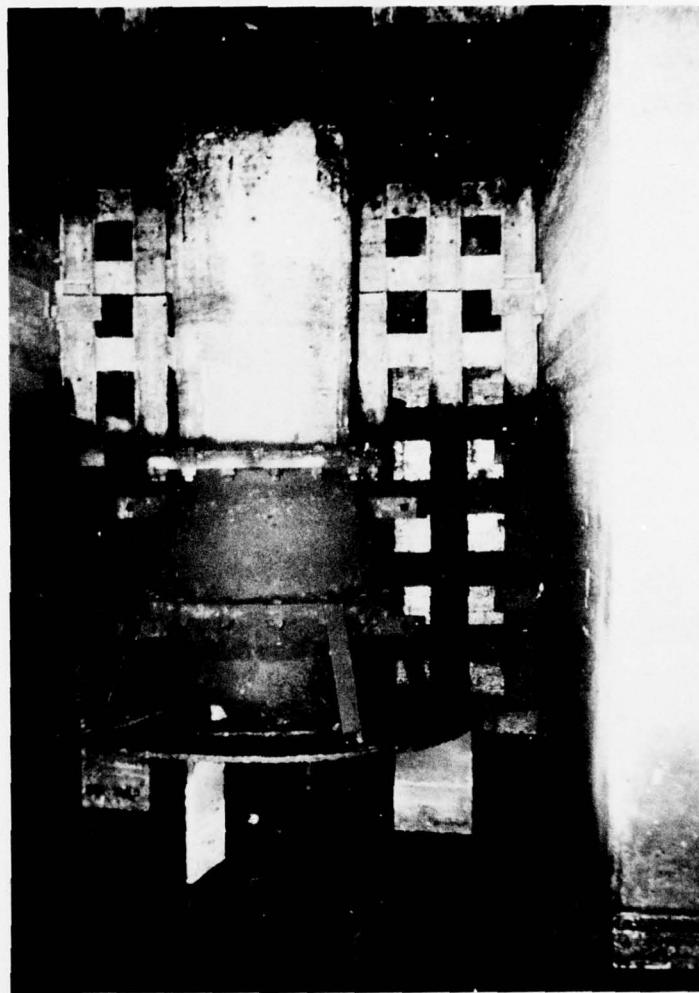
Figure 23. Vanes to straighten flow into the pump intake and a vertical grid on the back wall to attenuate vortex development

flow entering the pump intake; however, there is no documentation as to their effectiveness. At several pumping stations a vertical grid was installed on the rear sump wall (Figures 23 and 24) to reduce adverse circulation behind the pumps. Wooden grids (Figures 25 and 26) were installed horizontally to attenuate surface turbulence and reduce the tendency for vortices. Surface floats (Figure 27) have been used to prevent air entrainment in vortices; however, they do not prevent circulation of the flow and the associated area of low pressure. Fillets have been installed in corners and sidewall offsets in an attempt to reduce turbulence and flow separation.

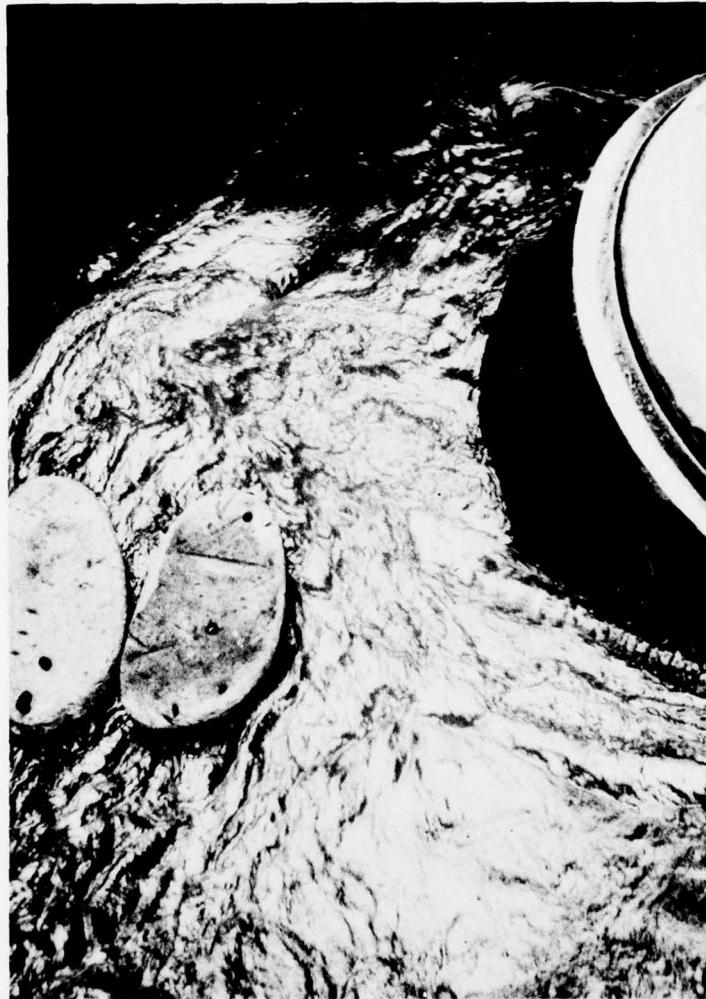
Figure 27. Surface floats to prevent air entrainment in vortices
